Ecoservices performs novel converter repair

Ecoservices' Dominguez plant in Carson, CA, recently replaced its converter's internal heat exchanger in a meticulously choreographed shutdown spanning 22 days in April 2022. Like many large construction projects, the replacement involved numerous moving parts. But a unique circumstance raised the complexity for the Dominguez plant—lack of precedent. Very few internal exchanger replacements have been performed in the industry.

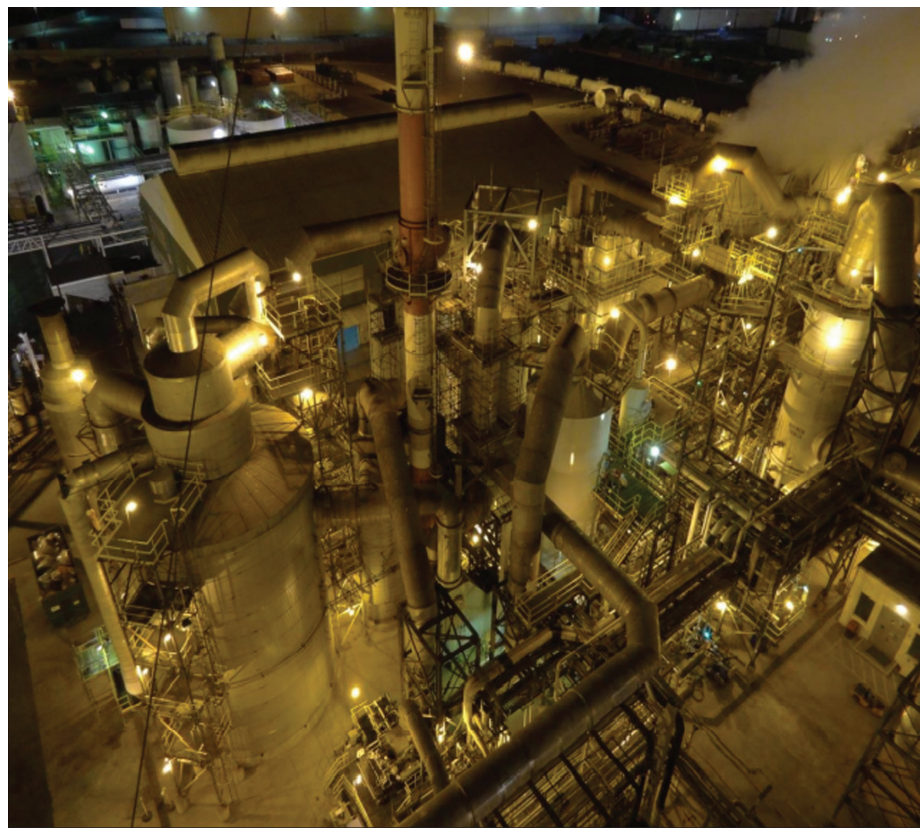
Ecoservices' Dominguez sulfuric acid plant recently replaced its converter's internal heat exchanger.

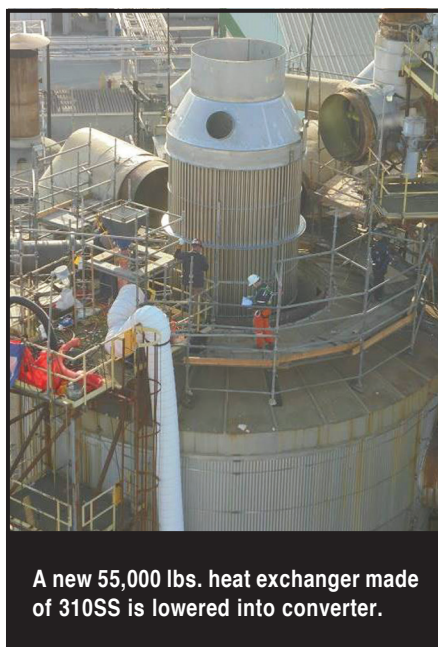
A new 55,000 lbs. heat exchanger made of 310SS is lowered into converter.

So Ecoservices' converter was retrofitted with a new Chemetics radial flow internal exchanger constructed from more resistant 310 SS. To help offset the cost of the metals upgrade, the shell section of the new exchanger was modified and the internal connections simplified to reduce the amount of material needed.

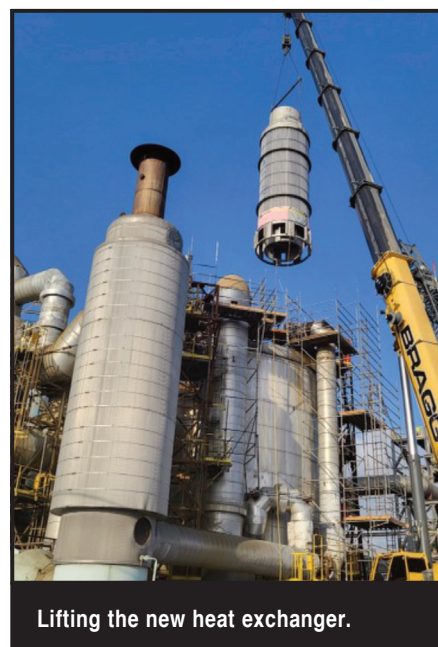
Lifting the new heat exchanger.

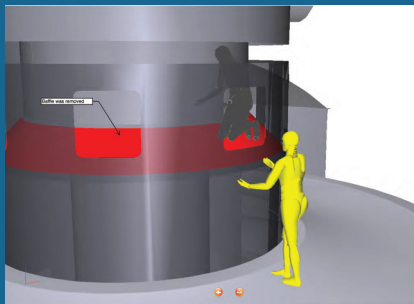
A virtual reality program furnished by Select Plant Services was used in the planning stage of the exchanger replacement. The planning team could don 3D goggles and virtually move throughout the converter/exchanger sections.

"The virtual reality program provided by Select Plant Services was a tremendous planning tool," said Jack Harris, President/CEO for VIP International. "It's one thing to look at the drawing and calculate the work and crawl space in such an intricate confined area. This program allowed our planning team to virtually move throughout the converter and exchanger after simulated sections were removed."

Because baffles are tightly fitted and not designed for replacing, removing them involved some imagination. "We used VR to model the space to make sure a person could maneuver where cuts were required," said Eickelman. "We also took the time to come up with "Plan B" in case the real world didn't agree with the VR world," he said.

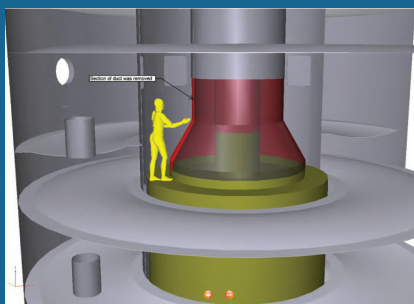
A section of duct is removed.

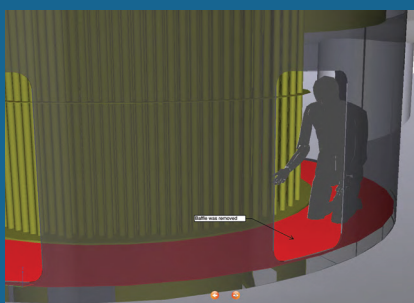
Baffle was removed

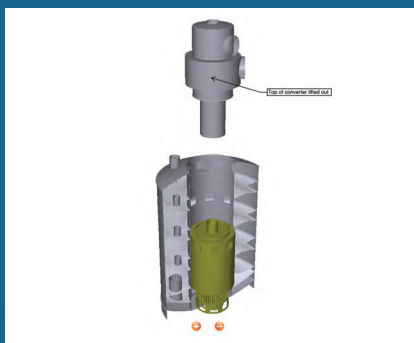
Top of converter is lifted out.

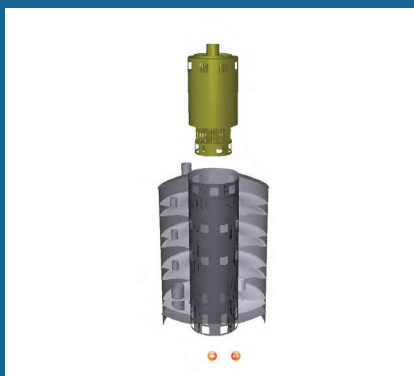
The facility's old exchanger is lifted out after 30 years of service.

Regarding lifting the old exchanger, there was no external case to contain the load. Knowing the center tube was too weak to reliably handle the weight, the team designed a separate carrying system and installed it in time to keep the overall job on schedule.

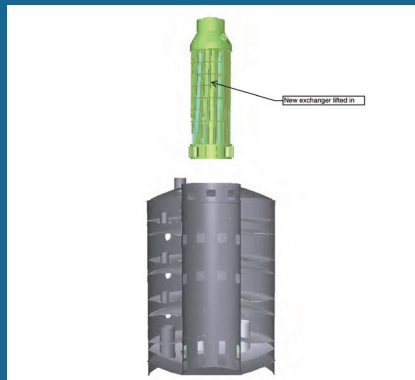
The new exchanger, designed and built by Chemetics, is lifted in.

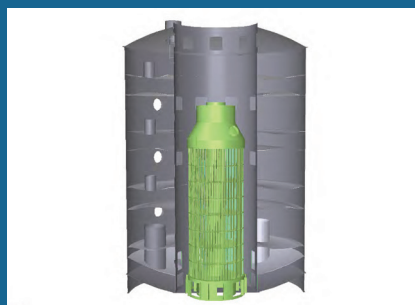
New exchanger in place.

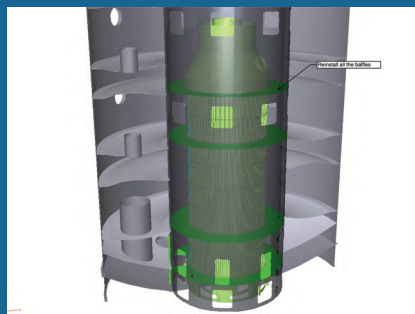
Baffles reinstalled.

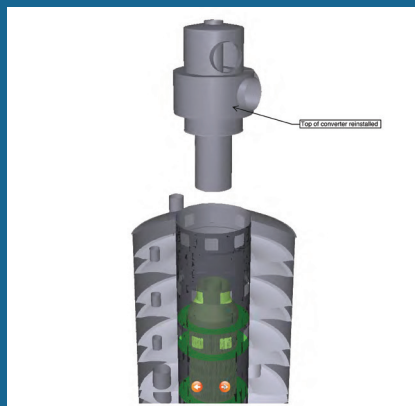
The top of the converter reinstalled.

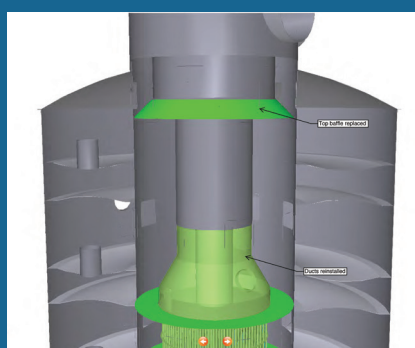
Top of baffle and ducts reinstalled.

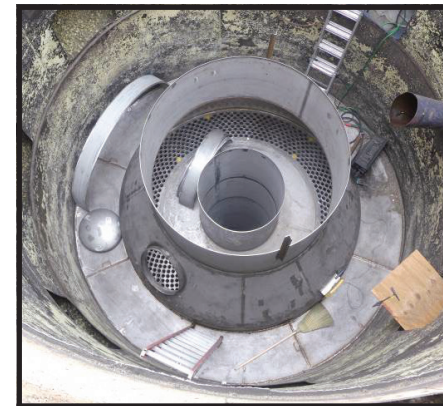
Top view of the newly installed exchanger.

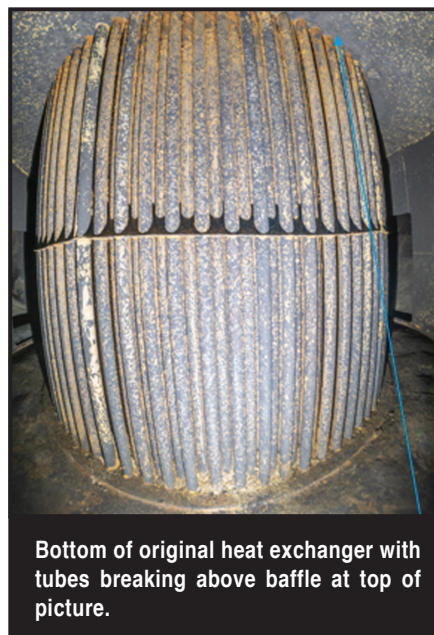
However, in 2020 when SO_2 to SO_3 conversion began to decrease, high-temperature sulfidation, a type of corrosion, was suspected. In February 2021 VIP International was called in for inspection and repairs. The visual inspection revealed the critical damage. "We found over 200 complete failures of tubes and severe delamination of many other tubes," said Gavin Floyd, Engineering Manager at Ecoservices. "This is the typical failure scenario when 304 H stainless steel is subjected to temperatures above 1,000 degrees F." While temporary repairs produced minor improvement it was deemed the exchanger had seen its useful life.

High temperature sulfidation is a largely diffusion controlled, high temperature, chemical corrosion process that gradually converts the stainless steel tube metal into various sulfides, sulfates, and oxides that crumble away. "The process is very slow for most industrial applications," said Jesse Huebsch, Acid Technology Service Engineer at Chemetics. "But higher temperatures and more oxidizing gases, including NO_x , intensify and accelerate the deterioration, as do multiple thermal cycles, which cause the scale to flake off." These were the conditions at Dominguez.

Bottom of original heat exchanger with tubes breaking above baffle at top of picture.

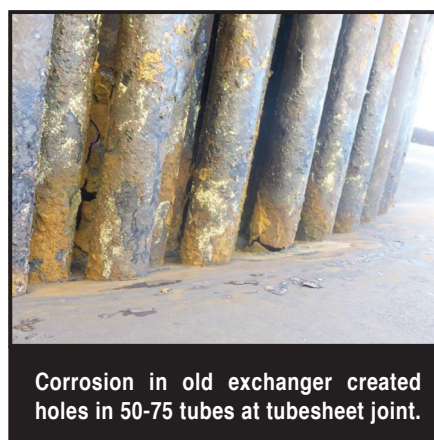
Corrosion in old exchanger created holes in 50-75 tubes at tubesheet joint.

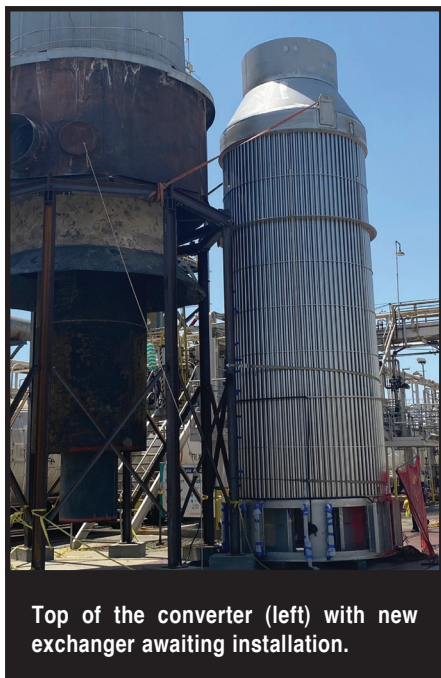
Top of the converter (left) with new exchanger awaiting installation.

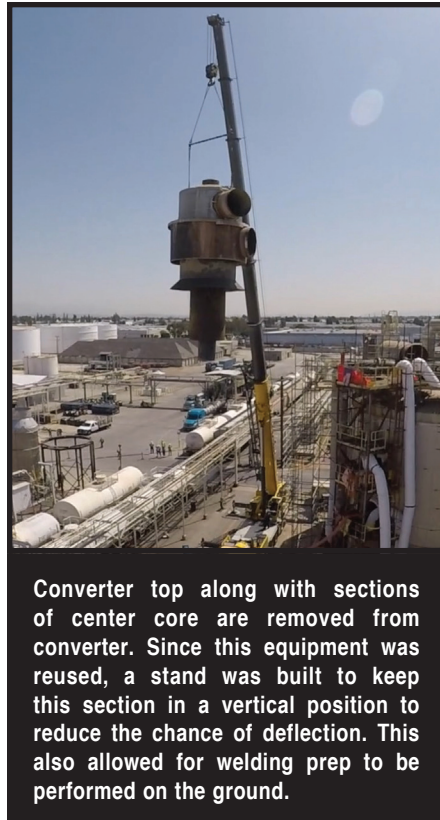
Converter top along with sections of center core are removed from converter. Since this equipment was reused, a stand was built to keep this section in a vertical position to reduce the chance of deflection. This also allowed for welding prep to be performed on the ground.

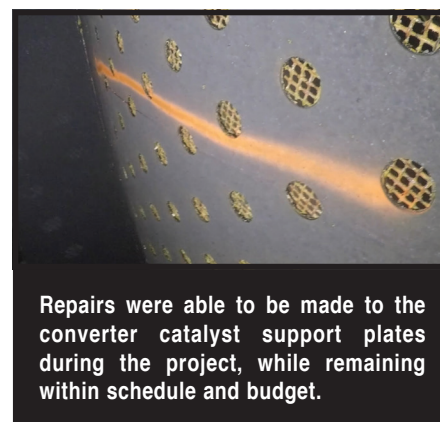
Repairs were able to be made to the converter catalyst support plates during the project, while remaining within schedule and budget.
